CONFIDENTIAL INSPECTION REPORT

123 Abc St., St. Marys, GA 31558

11/8/2011 2:00 pm to 5:30 pm

SUMMARY REPORT

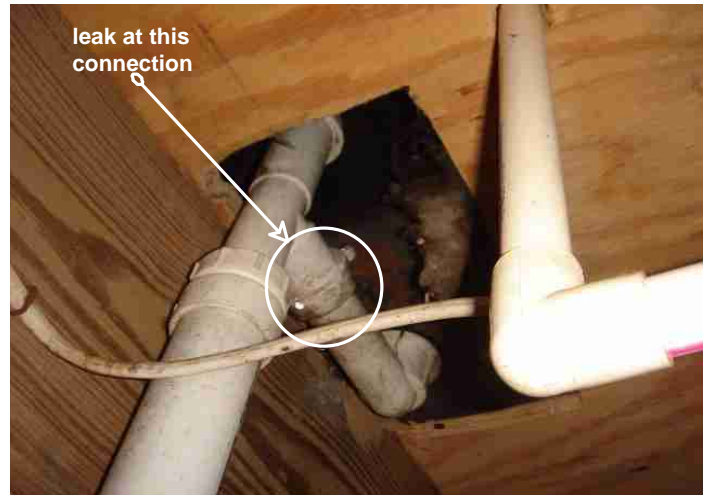
4.3 - There are drainpipe leaks at the following locations which should be repaired: cap connection at the master bathroom tub and stall shower drain pipes are connected to Y connection; Jack and Jill Bathroom bathtub drain line.

There is a drainpipe leak that we will identify - *Continued*

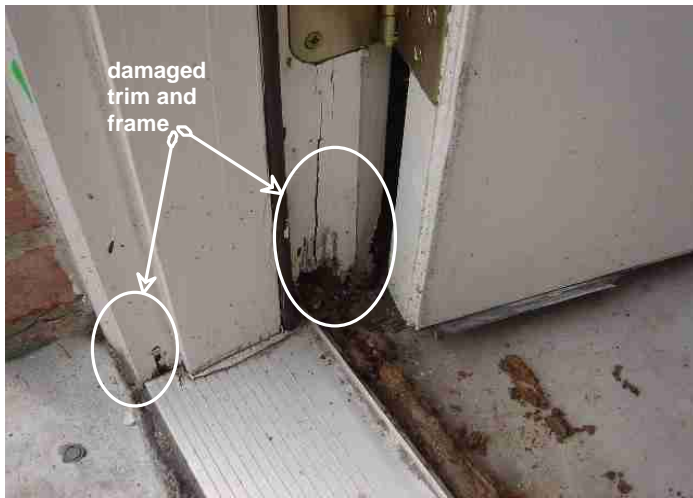
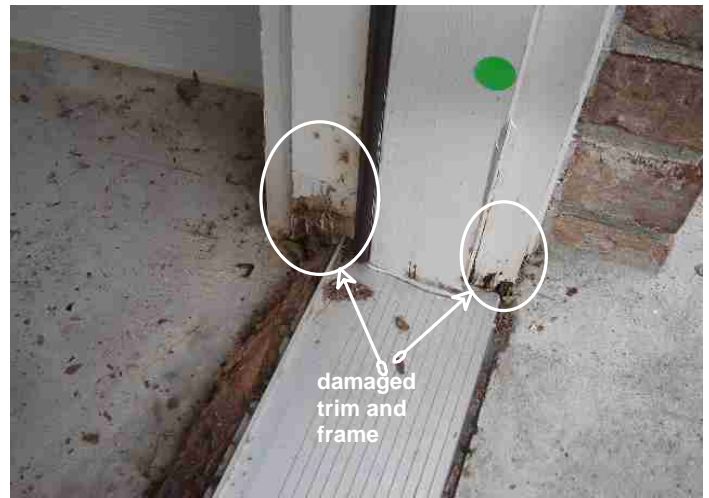
16.2 - Wood borer damage was noted to the frame, trim and threshold of the garage side door which should be further evaluated by a licensed WDO inspector.

Wood borer damage was noted to the frame of garage side door - *Continued*
