PROPERTY CONDITION REPORT

Main St., Jacksonville, FL, 12345

12/1/2011 from 9:00 AM to 7:13 PM

General Information

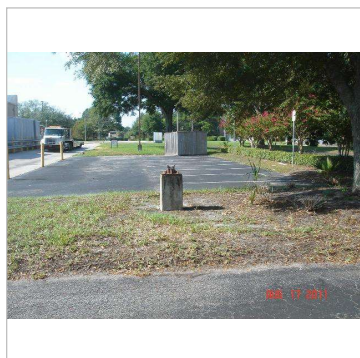
- 1.1.8 A public street light located at the rear of the drive through is missing and you may wish to contact the public utility to have it replaced.

Figure 1A - Public street lamp missing

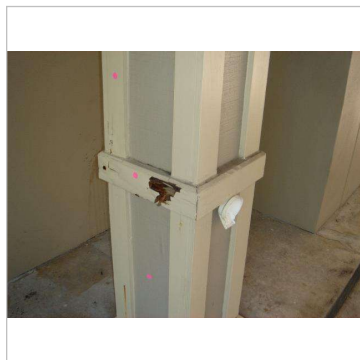
- 1.1.14 The property is served by automatic sprinklers. The coverage appears to be adequate, however, one head at the rear is over spraying on to the rear column causing wood rot damage, and should be serviced.

Figure 2A - damaged trim and siding on rear post due to sprinkler overspray

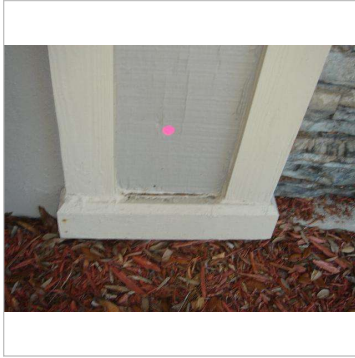
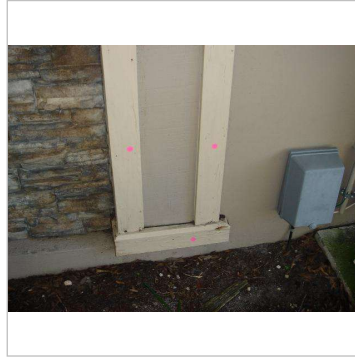
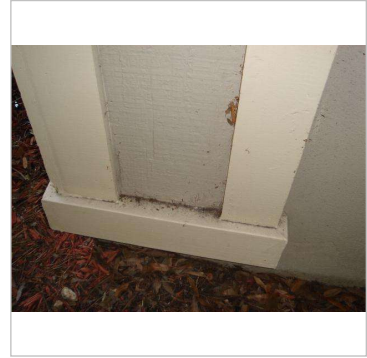
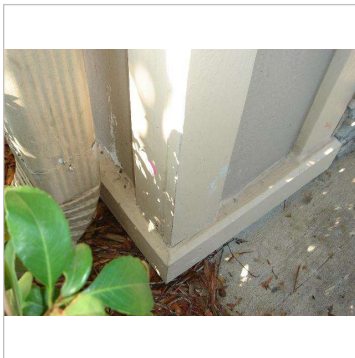
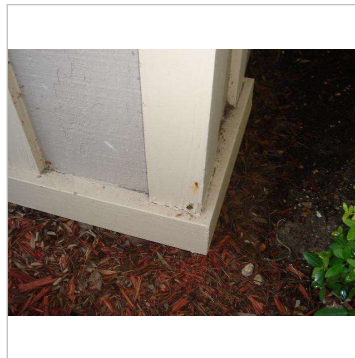
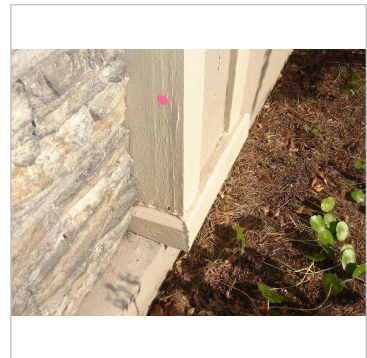
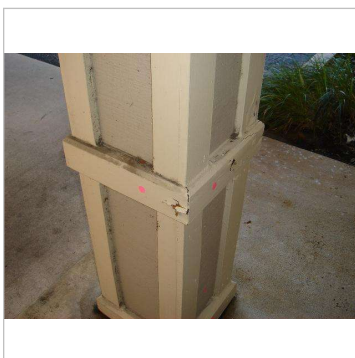
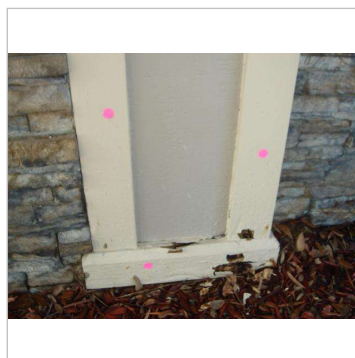
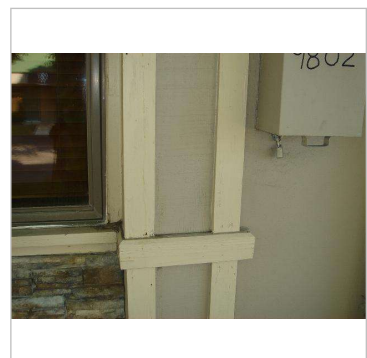
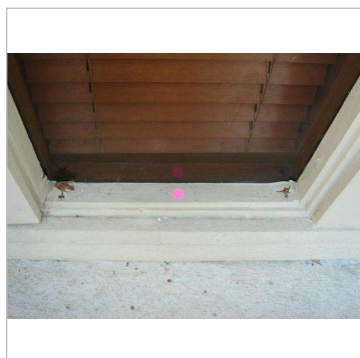
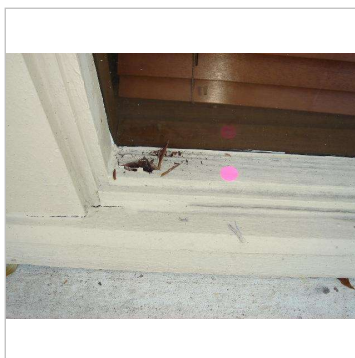
- 1.1.27 The siding is dry rot damaged in places and should be repaired. Areas of wood rot damage were marked with colored dots and include trim and siding on the front, right, and left walls and on a rear column.

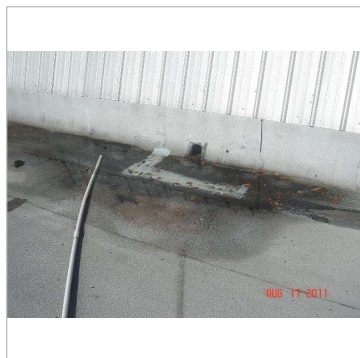
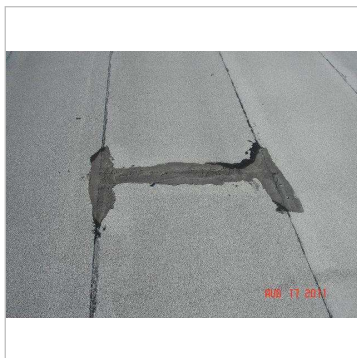
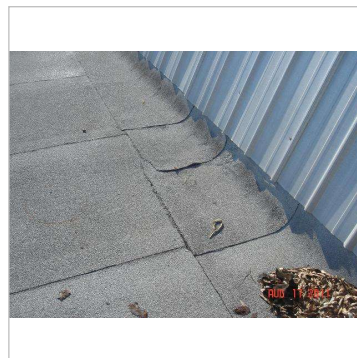
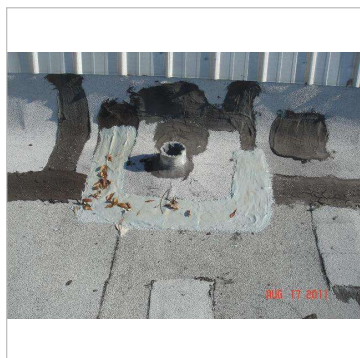
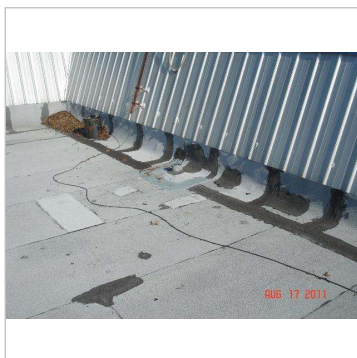
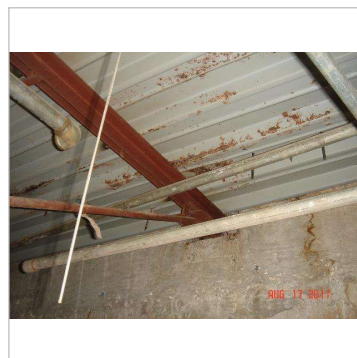
- 1.1.37 There are apparent deficiencies with the roofing material such as moisture stains within the structure that we will identify. However, active leakage can be difficult to trace and confirm when it is not raining, and you should ask the sellers about this, or have the roof water-tested before the close of escrow. The roofing material has been patched at the seams, drainage scuppers, and on parapet walls with mastic roof cement and urethane type caulking. Stains and water damaged tiles were noted under the roof at the west side and standing water was noted at one of the scuppers on the west side of the roof. Some corrosion and minor damage to metal roof components was also noted in this area. Ongoing maintenance including patching should be expected in the future.

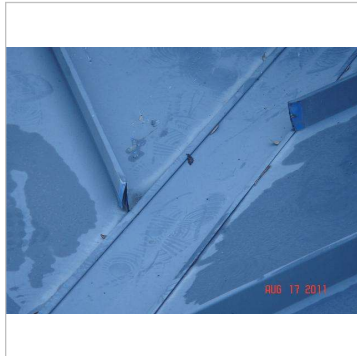
- 1.1.40 The seams of the metal caps on the parapet walls need to be re-capped at a rear valley.

Figure 6A - caps missing on standing seam in rear valley

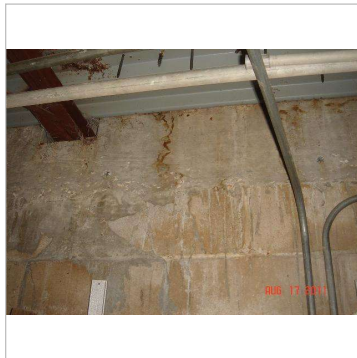
- 1.1.49 The visible portions of the framing appear to be in acceptable condition (metal truss system, some corrosion noted at west side wall but it is not significant and active leakage was not determined at this time).

Figure 8A - minor corrosion to truss end and metal roof deck noted

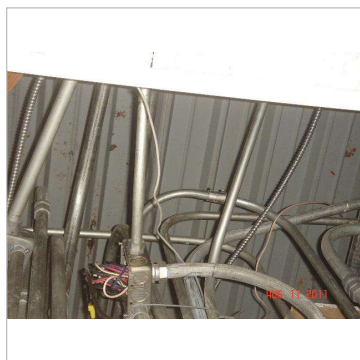
- 1.1.51 There are open electrical junction boxes, which should be sealed to contain any arcing or sparking that might occur.

Figure 9A - Open junction box

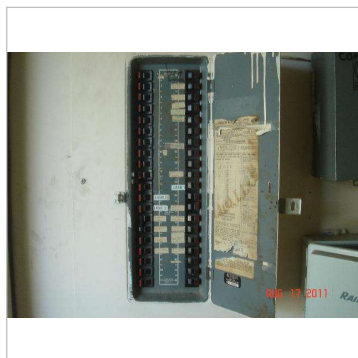
- 1.1.67 The electrical sub panel has no visible deficiencies.
- 1.1.68 The 175 amp sub panel was manufactured by Federal Pacific Electric Company and employs Stablok circuit breakers and other components that have been alleged to be defective. However, the panel is old and the company is now out of business, and although field reports of defects and dangers were never apparently substantiated by laboratory tests they have been numerous and serious enough for us to recommend that you seek a second opinion from a licensed electrician.

Figure 10A - Federal Pacific type sub panel

- 1.1.69 The Federal Pacific panel employs Stablok circuit breakers that have been alleged to be defective, and should be evaluated by an electrician.

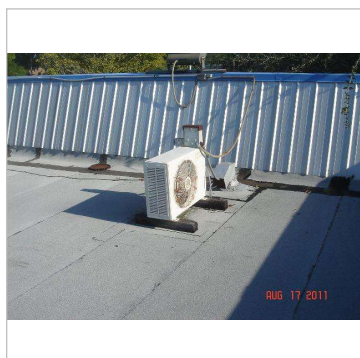
Figure 11A - Sanyo 9000 btu split system

- 1.1.87 The Sanyo air-conditioning responded, but only achieved a low differential temperature split between the air entering the system and that coming out. This could indicate that the system is low on refrigerant, and should be serviced. The remote control battery is also dead.

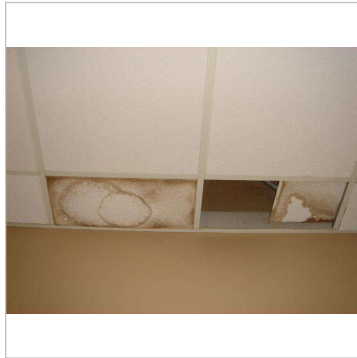
- 1.1.103 There are moisture stains and damaged tiles on the ceiling in the hallway.

Figure 16A - stains and missing ceiling tiles in hallway to the break room and bathrooms

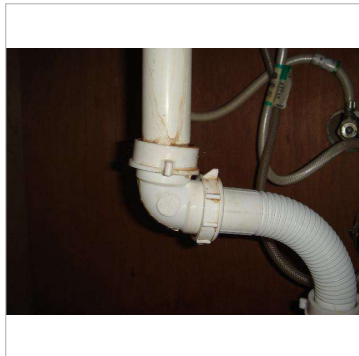
- 1.1.107 There is a leak at the drain trap below the sink, which should be repaired.

**Figure 17A - break room sink
drain line leak at this connection**

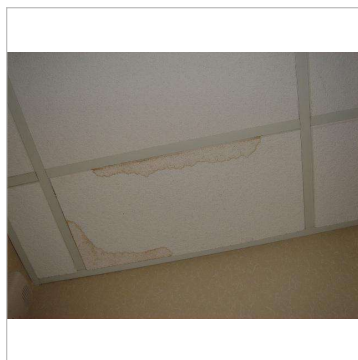
- 1.1.116 The ceiling tiles are stained in the manager's office #1 at the north side.

**Figure 18A - stains on ceiling tile
in manager office**

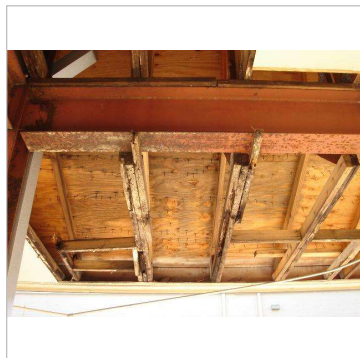
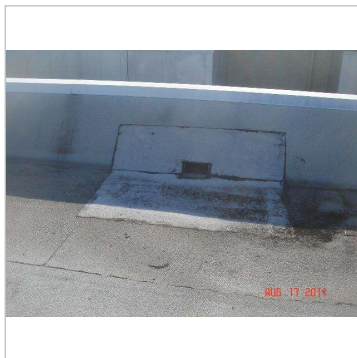
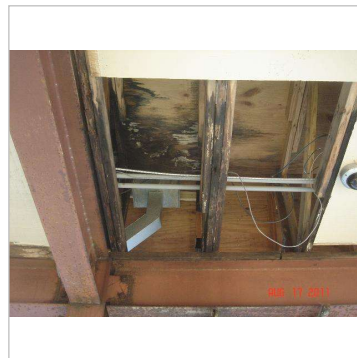
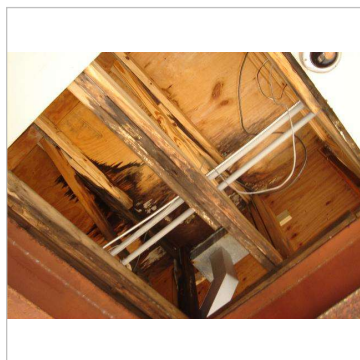
- 1.2.5 There are moisture stains and damaged to framing components within the canopy structure that need to be repaired. The damage was due to leakage at the roof drainage scupper, which has been repaired, however the roof decking plywood is moisture damaged and the underlying trusses are also damaged. Repairs to trusses should comply to engineered plans for truss repair.

Figure 19A - damaged roof framing above drive thru

Figure 19B - repair at scupper drain

Figure 19C - damaged roof deck and underlying wood trusses

Figure 19D - damaged roof sheathing above drive thru
