## Elite Inspectors, LLC

## PROPERTY CONDITION REPORT

13255 Atlantic Blvd., Jacksonville, FL, 32225

11/7/2011 from 9:30 AM to 12:30 PM

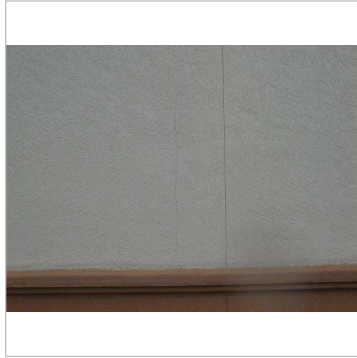
- 1.1.19 There are some obvious settling cracks that it would be prudent to seal, to forestall any possibility of moisture intrusion.

**Figure 5A - common cracks on masonry wall on left side**

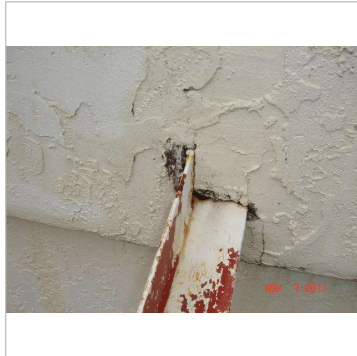
1.1.20 The stucco is leaking in places on the facads, as a result of cracks and penetration of angle iron anchors, and should be serviced. Leakage was noted through the ceiling under the facade at several areas including the west and south elevations. Infra red imaging revealed at least one are of high moisture and intrusion beneath the stucco cladding on the facade. Further evaluated and repair is needed by a stucco specialist or contractor.

**Figure 6A - penetration into facade wall by anchor is not sealed**

<b>Immediate Cost</b>	<b>Units</b>	<b>Cost/Unit</b>	<b>Total Cost</b>
Service facade over front entry for moisture intrusion and possible hidden damage and also service the parapet walls and flashings as necessary	1.00	25,000.00	25,000.00

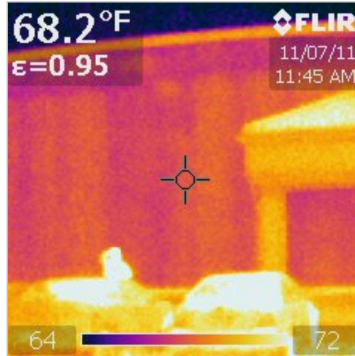
**Figure 6B - leakage at parapet wall on left side**

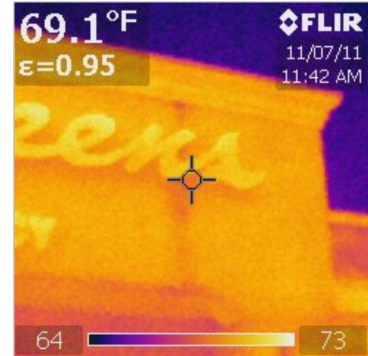
**Figure 6C - leakage at front, above and under letter n**

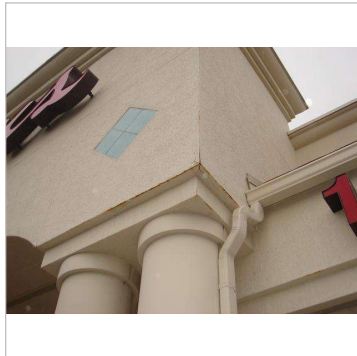
**Figure 6D - corrosion and stains on stucco walls at front right corner**

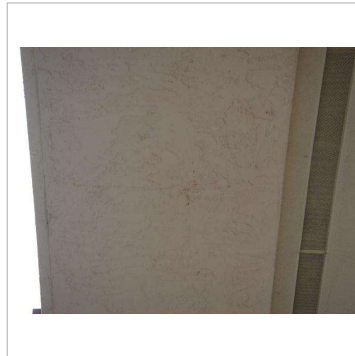
**Figure 6E - cracks in stucco-stains on soffit at front-2**

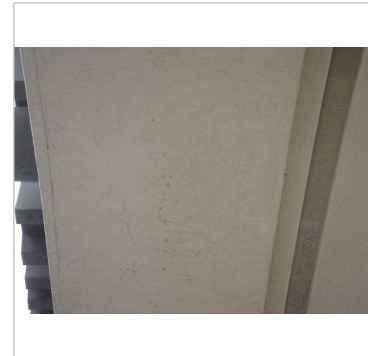
**Figure 6F - cracks in stucco-stains on soffit at front**

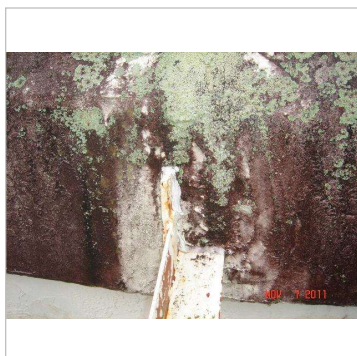
**Figure 6G - sealed anchor into mold like growth on facade**

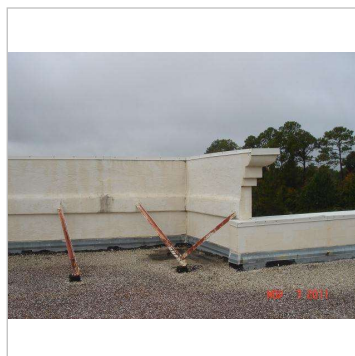
**Figure 6H - water ponding on roof at west side facade**

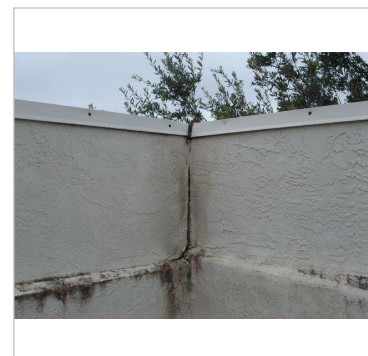
**Figure 6I - cracks at facade wall intersections**

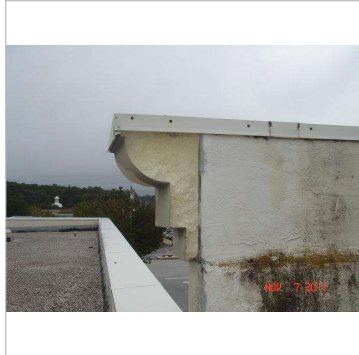
- 1.1.21 Some areas of the building walls appear to be finished or trimmed with a synthetic stucco, also known by the acronym EIFS, or Exterior Insulation and Finish Systems, which is subject to impact damage, cracking, and general wear. This type of wall finish is present in the bands and finish on the columns and other decorative surfaces on the exterior walls of this building. Cracks in the material on the column bases was noted, and one of these decorative structures located on the facade at the southeast section is damaged. Repairs by a specialist is needed.

**Figure 7A - decorative banding is damaged-foam is showing in this photo**

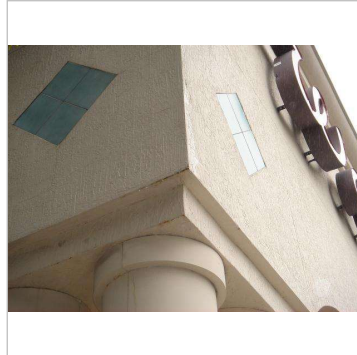
**Figure 7B - corrosion and stains on stucco walls and stucco bands at front left corner**

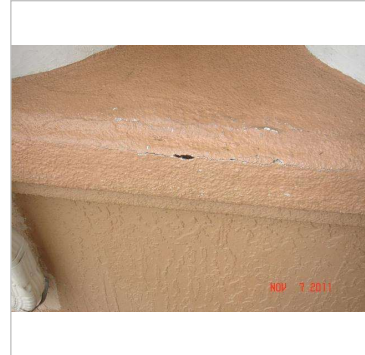
**Figure 7C - cracks in column base stucco banding**

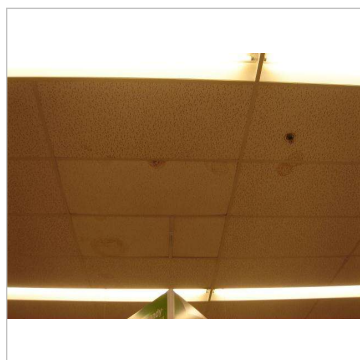
- 1.1.29 Although there are no apparent deficiencies with the roofing material, there are moisture stains within the structure that we will identify. However the stains on the ceiling tiles are dry at this time despite steady rainfall.

Figure 11A - dry stains over aisle #5

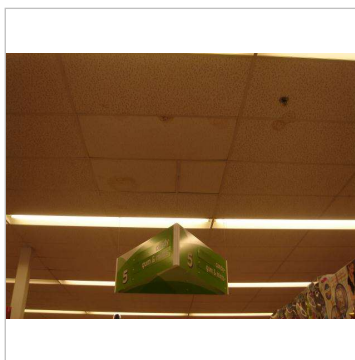
Figure 11B - dry stains on ceiling tiles over aisle #5

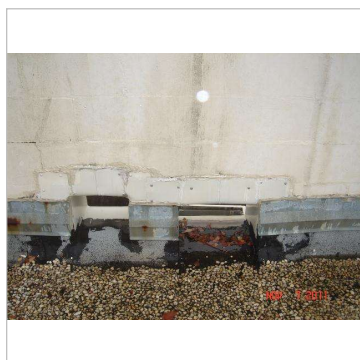
- 1.1.30 The scuppers roof drains and the drainage channels are in acceptable condition. However, without water it is difficult to judge whether they are correctly pitched to direct water into the drains, but they should function as they were intended.

Figure 12A - Scuppers at rear appear to have been sealed and re-flashed

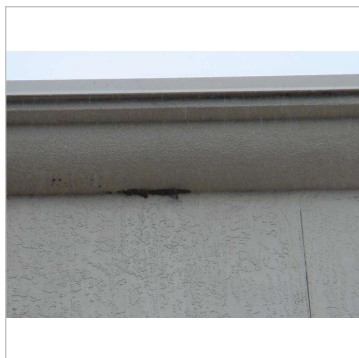
- 1.1.31 The tops of the parapet walls are not adequately sealed, which has allowed moisture to penetrate. Some leakage signs noted on the west wall. There are also cracks in the block parapet walls that should be serviced or sealed.

Figure 13A - Evidence of leakage on parapet wall at left side

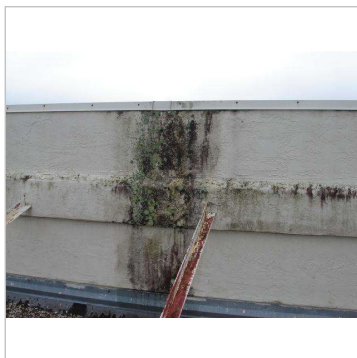
Figure 13B - stains on facade-1

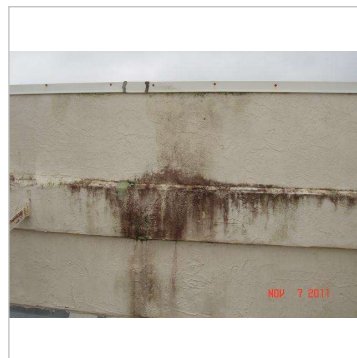
Figure 13C - stains and cracks in stucco on facade wall

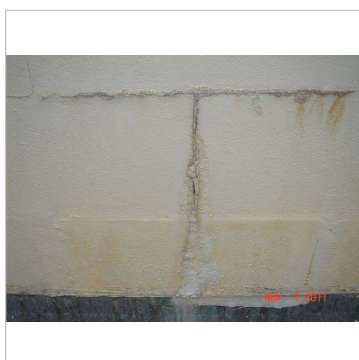
Figure 13D - cracks and efflorescence in block parapet wall

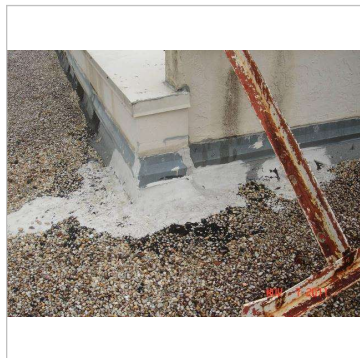
- 1.1.37 Although there are no apparent deficiencies with the roofing material, there are moisture stains within the structure that we will identify. However, active leakage can be difficult to trace and confirm when it is not raining, and you should ask the sellers about this, or have the roof water-tested before the close of escrow (stained ceiling tiles noted inside the store and areas of patched repairs noted on the roof at the front intersection of parapet wall and facade, and at the scuppers at the rear).

**Figure 15A - patched area of roof at the intersection of parapet wall and front facade**

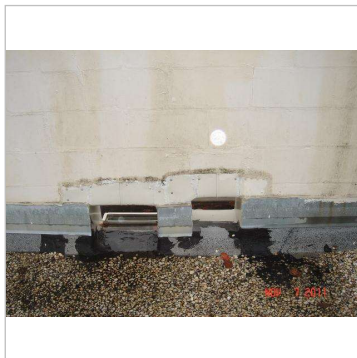
**Figure 15B - sealant on flashing and roof at scuppers**

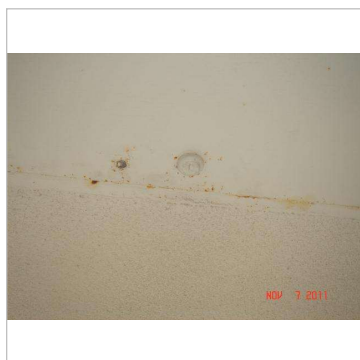
- 1.1.38 The drive through and facade attic access hatches were sealed which prevented entry. The panel locks are painted over and could not be unlocked. As a result, these spaces were not accessed.

**Figure 16A - access hatch to facade is painted over**

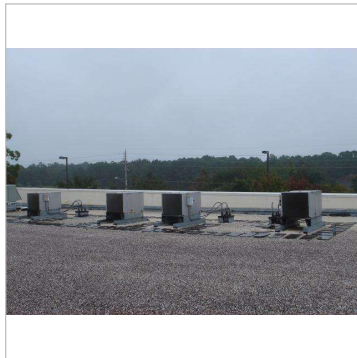
- 1.1.107 The compressors for the coolers are old, and will obviously not be as efficient as a newer model and should not be expected to last indefinitely. They are located on the roof top. It was noted that one of the units has worn insulation on the refrigerant line and icing on the suction line was noted at the time of the inspection. Further evaluation by an refrigeration specialist is needed to determine service requirements.

**Figure 25A - 4 compressor units for in-store coolers**

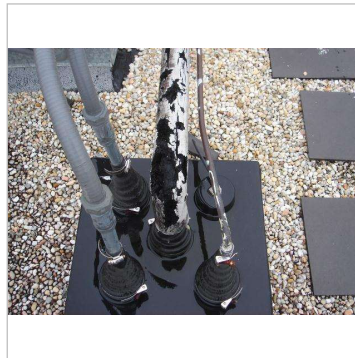
**Figure 25B - damaged insulation on refrigerant line**

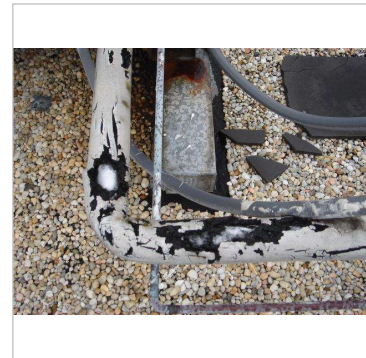
**Figure 25C - icing on refrigerant line of 2nd smaller unit, and worn insulation**

components, and also to the roof components such as the parapet walls and their components. It is also our recommendation that the compressor units for the coolers be serviced or at least have records of recent service by a refrigeration specialist, and the one unit that is icing by serviced by a professional.
