**CONFIDENTIAL INSPECTION REPORT**

123 Abc St., St. Marys, GA 31558

11/8/2011 2:00 pm to 5:30 pm

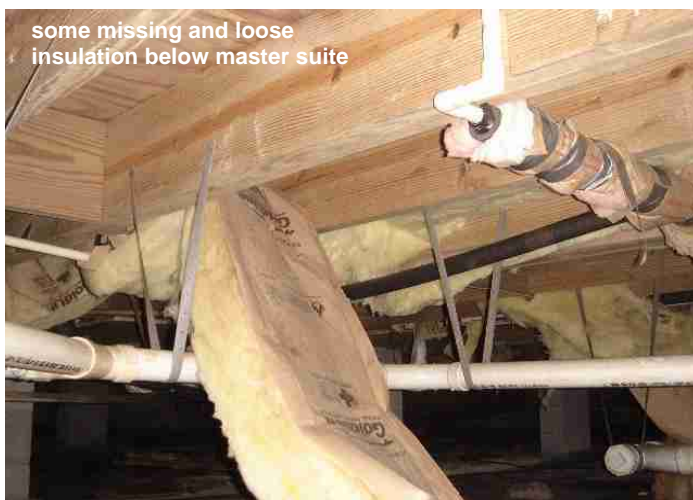
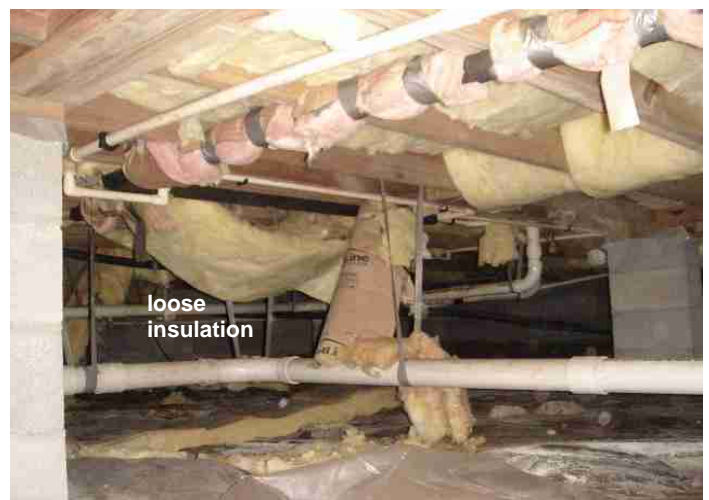
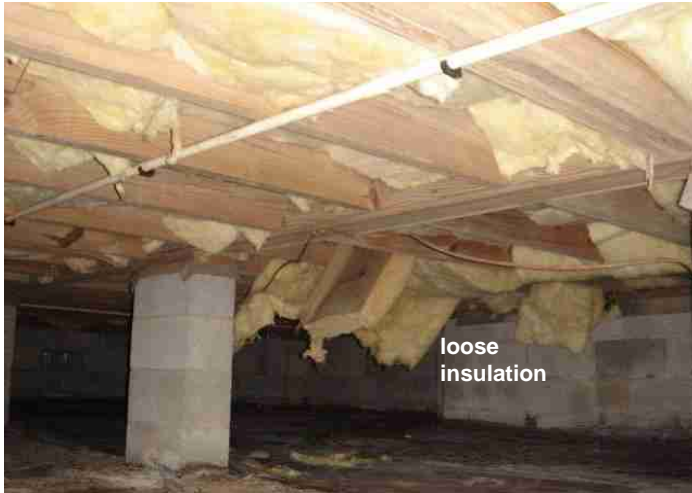
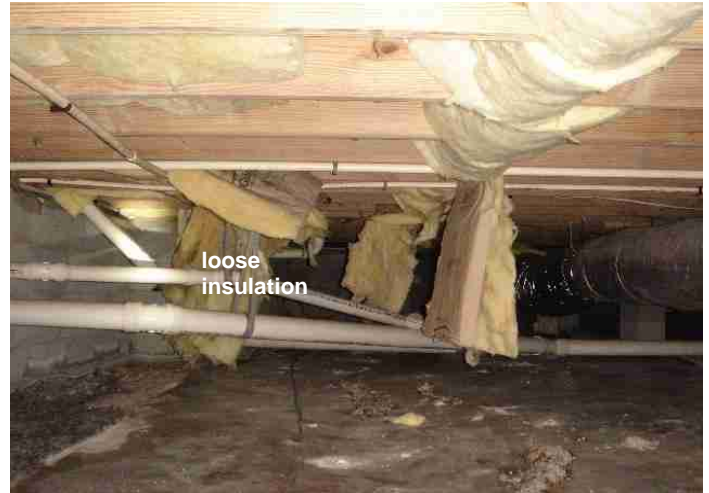
1.14 - Some pieces of insulation are hanging or have fallen from between the floor joists. This does not have any serious consequences, but you may wish to have it serviced.

Some pieces of insulation are hanging or have fallen from between the floor joists - *Continued*

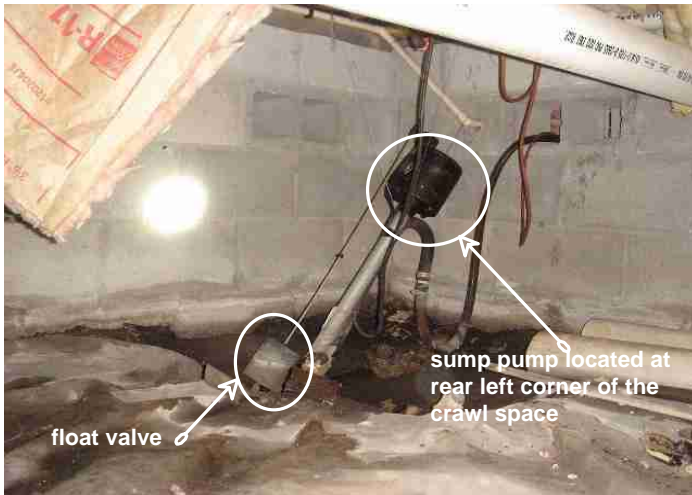
2.9 - The crawlspace could be subject to moisture intrusion, but is equipped with a float-activated sump pump. Common sense dictates that moisture should be handled before it even enters a residence, but many residences do have sump pumps. Nevertheless, the crawl space area and the sump-pump should be periodically monitored, and particularly before each rainy season, and storage items should be isolated from the floor and walls.

The crawlspace could be subject to moisture intrusion but is equipped with a float-activated sump pump - *Continued*

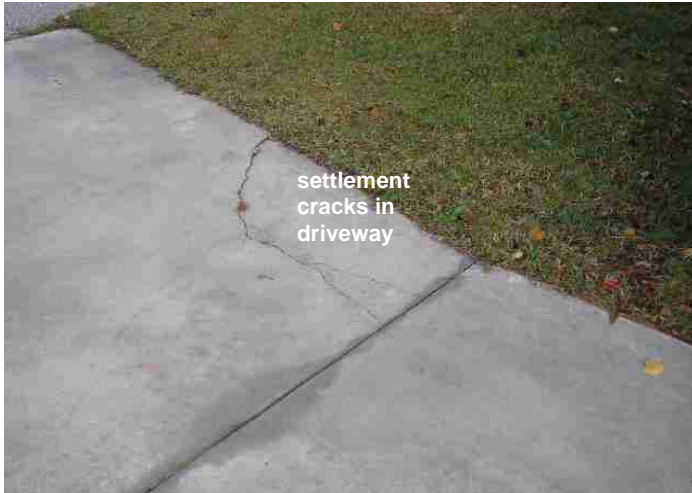
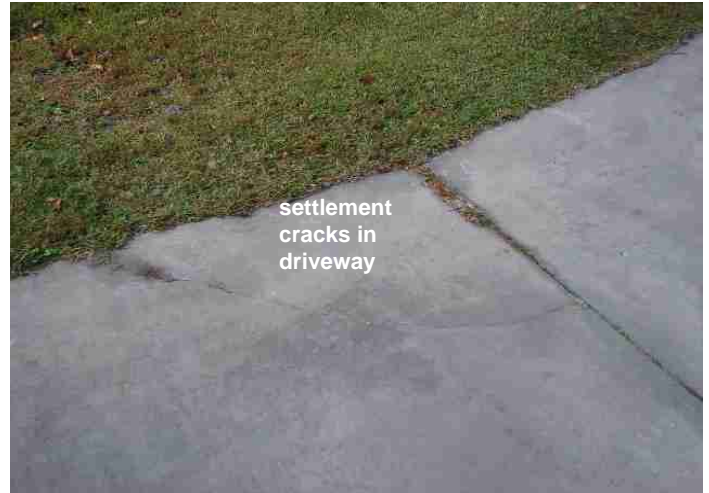
2.14 - There are predictable cracks in the driveway that would not necessarily need to be serviced.

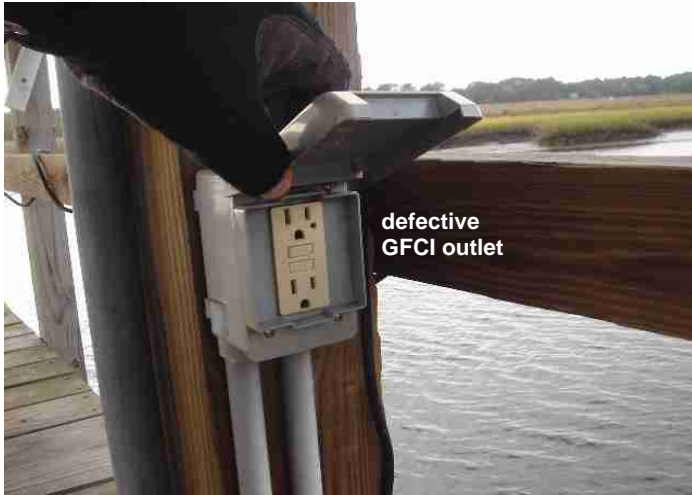
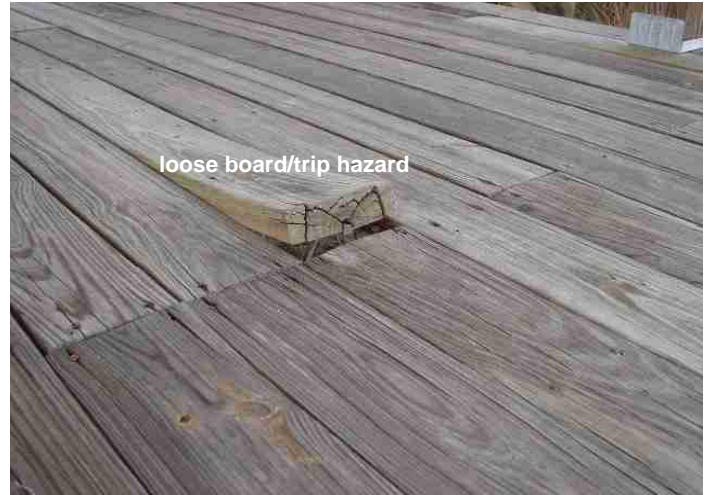
2.30 - Inspection of docks including floating portion are limited to what is visible above the water level. Further evaluation by a specialist is advised. However following issues were noted on what is visible and accessible: loose boards and missing fasteners were noted at various areas; loose railing; missing edge board on the floating dock; portion of the deck joists detached at the top of the ramp; wiring for the floating dock light is exposed and should be installed in a conduit (portion of it was installed in a conduit); fan blades are missing; GFCI outlet is defective and should be replaced; opening in the boat lift control box should be covered.

Inspection of sea walls and docks are limited - *Continued*

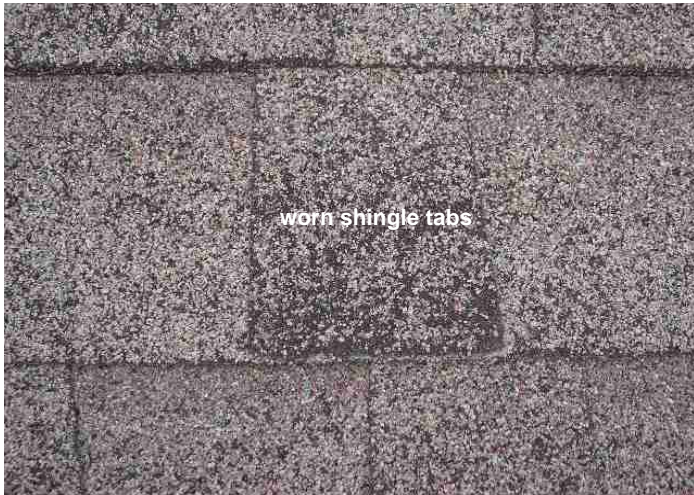
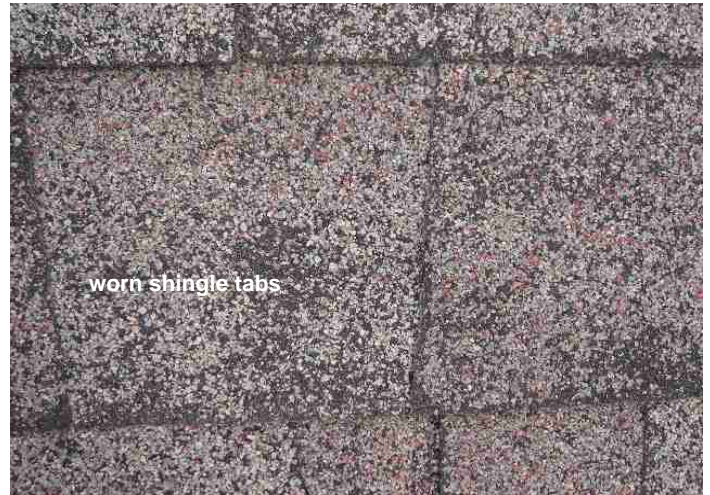
3.4 - The roof is in the primary stages of decomposition, which means that the roof is in decline and susceptible to leaks. It will need to be maintained and closely monitored, because it is reaching the end of its serviceable life, and you may wish to have a second opinion before the close of escrow. Probability of replacement within five years is medium.

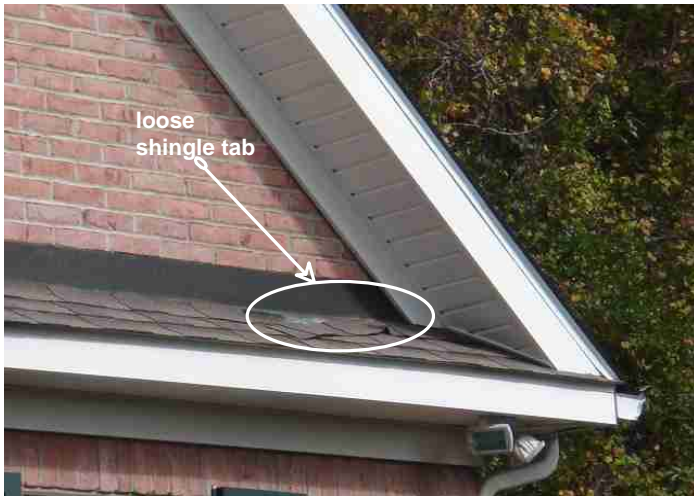
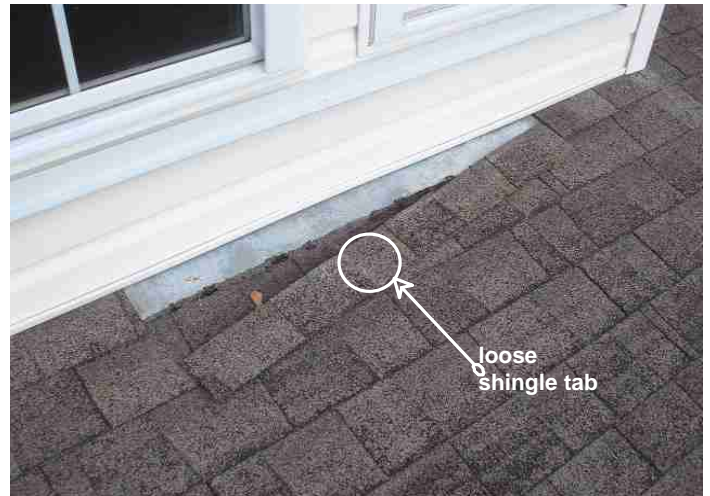
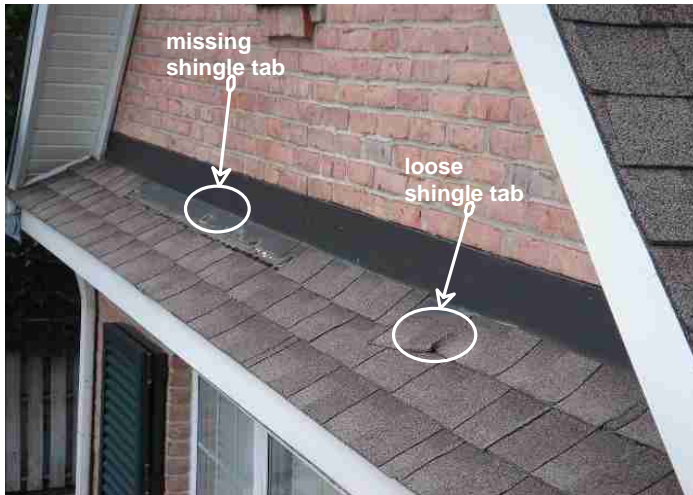
3.5 - Shingle tabs are loose or missing on the flashing at various areas. Shingles are installed to hide the metal portion of the flashing and is more of a cosmetic look rather than protection purposes.

Shingle tabs are loose or missing on the flashing at various areas - *Continued*

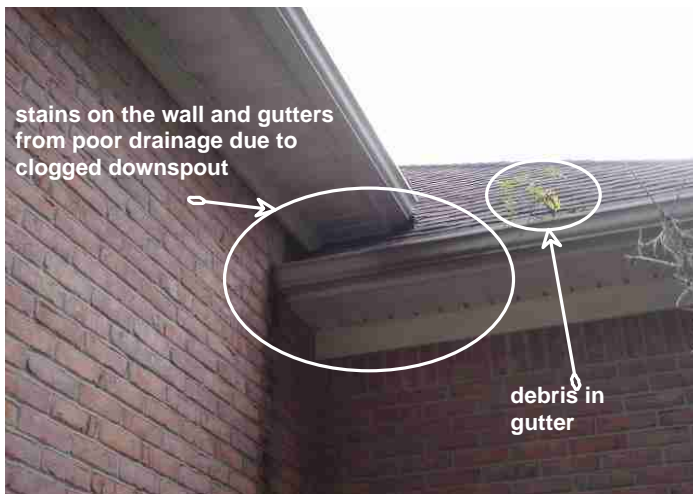
3.7 - The gutters need to be cleaned and serviced to drain properly.

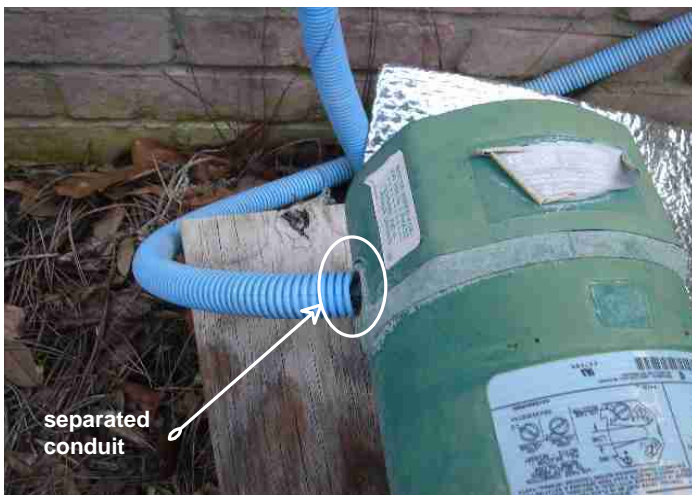
4.30 - Electric wire conduit is separated at the pump connection, which does not have proper clamp and should be serviced.

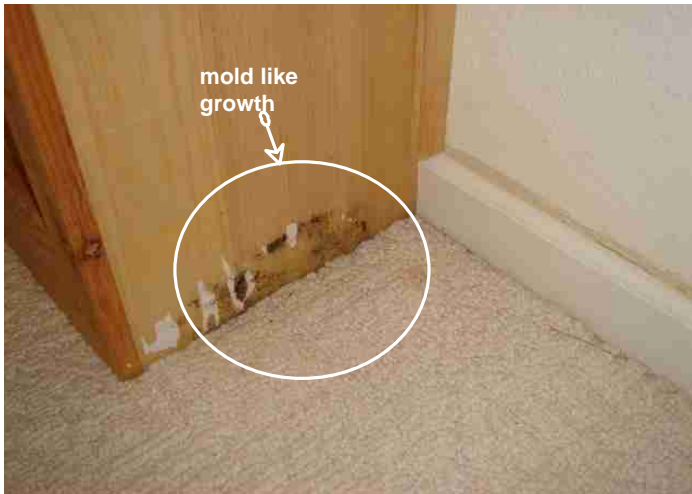
9.33 - There is a mold like growth on the side of the shelf near the window, which should be disinfected.

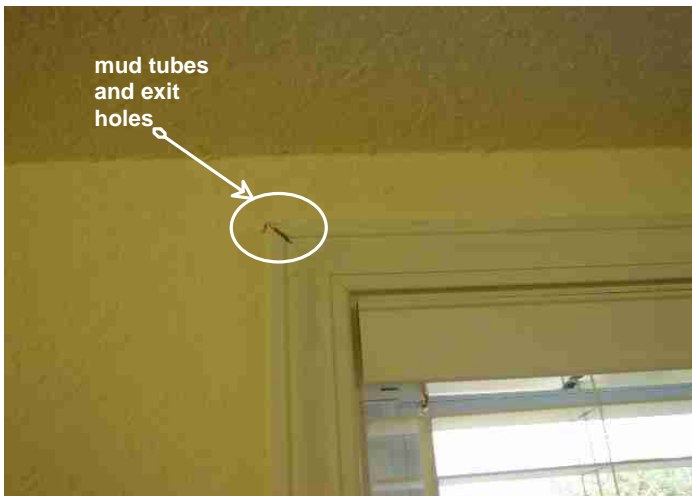
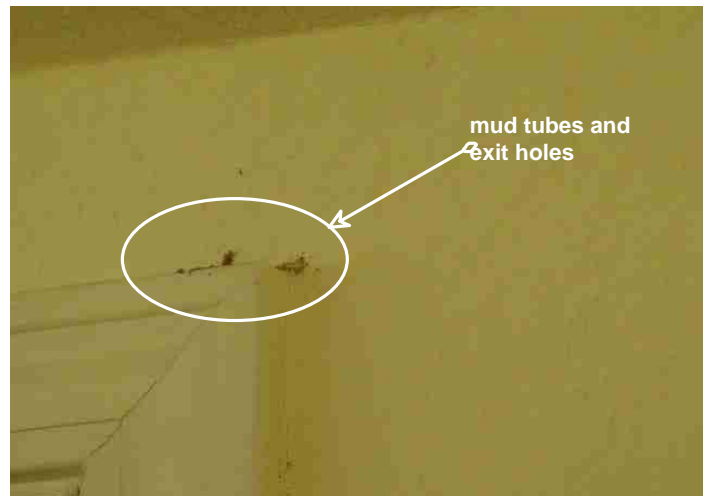
9.34 - There is evidence of wood borers in Bonus Room which should be further evaluated by a WDO inspector (exit holes and mud tubes on the wall above and below the window; mud tubes on the window trims; exit holes at wall and ceiling intersections). Area is not visible from attic due to vaulted ceiling.

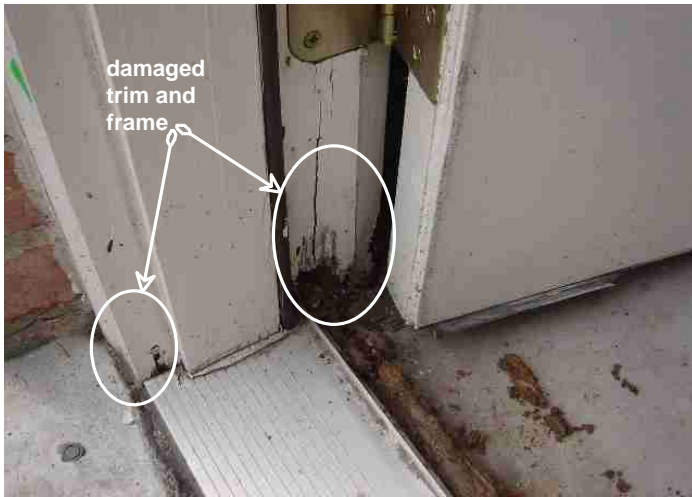
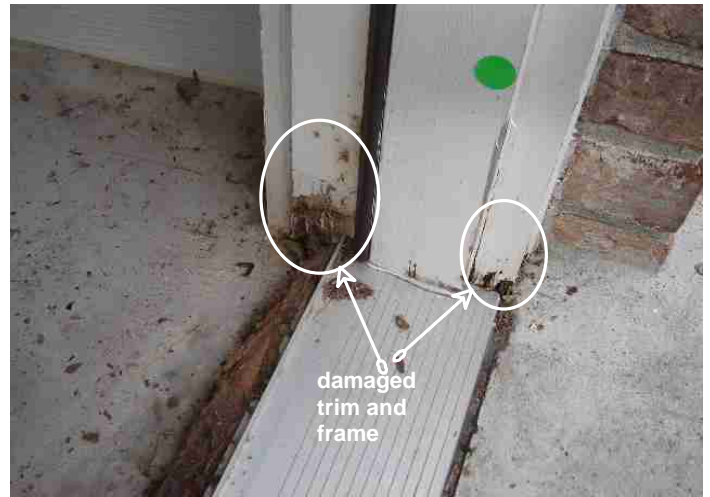
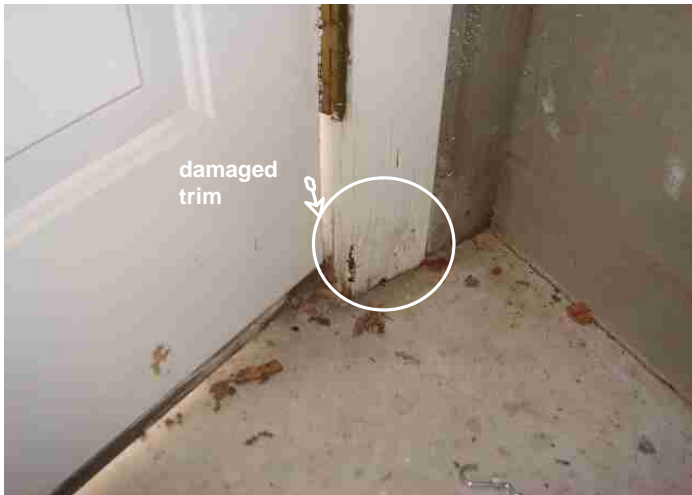
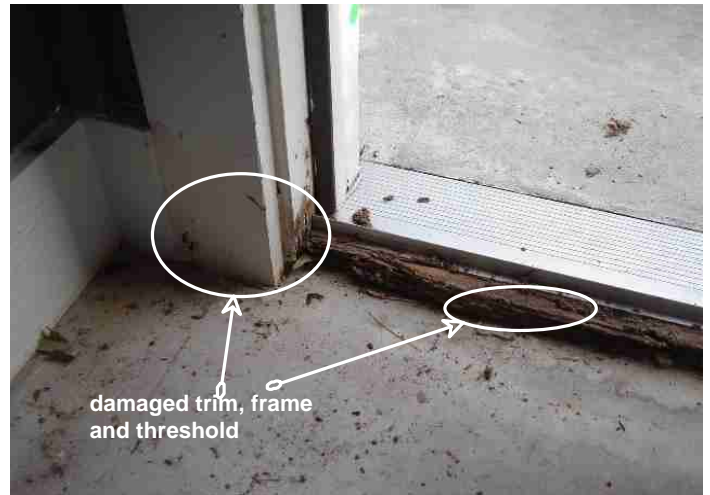
16.6 - Wood borer damage was noted to the frame, trim and threshold of the garage side door which should be further evaluated by a licensed WDO inspector.

**Wood borer damage was noted to the frame of garage side door - *Continued***

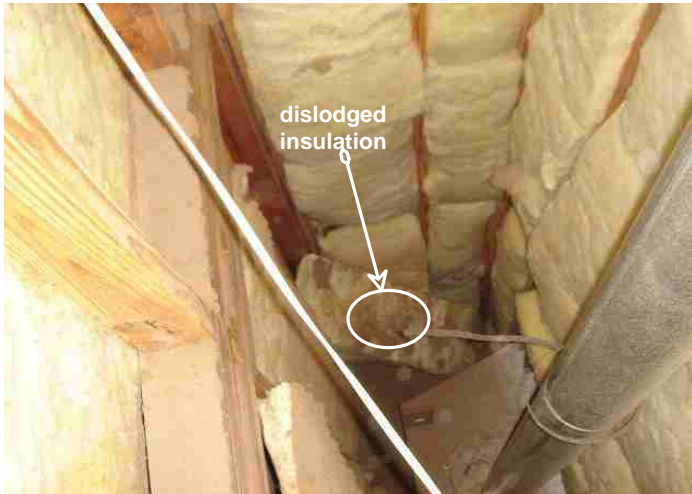
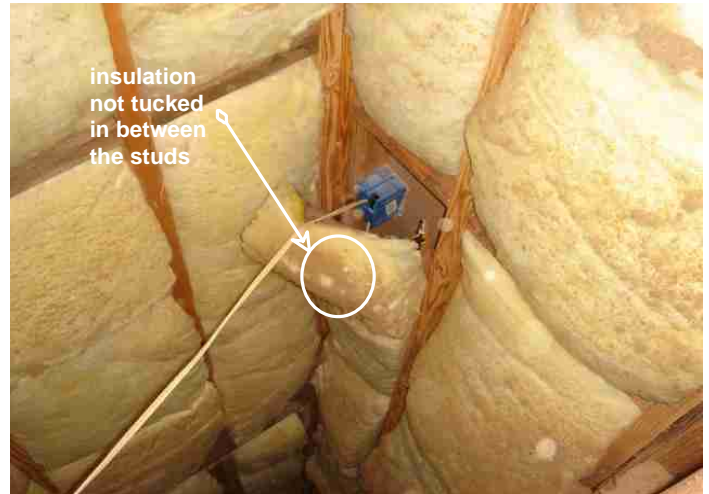
17.12 - Dislodged insulation was noted in the attic that you may want to have re-installed (at chimney chase back wall; bonus room left side wall).
