PROPERTY CONDITION REPORT

Main St., Jacksonville, FL, 12345

12/1/2011 from 9:00 AM to 7:13 PM

General Information

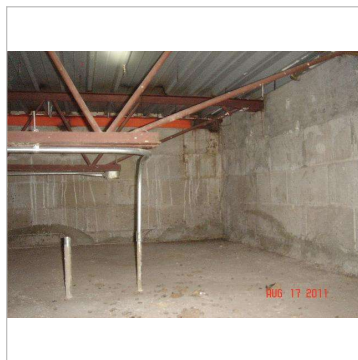
- 1.1.24 The roof is framed with metal rafters, purlins, etc.

Figure 3A - View of steel truss supporting metal roof deck

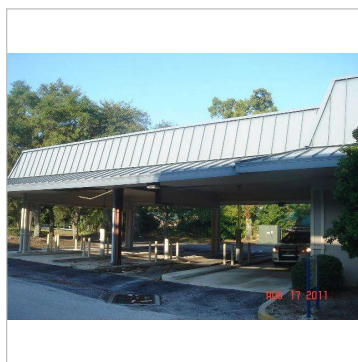
Figure 7A - metal standing seam overhang and fascade

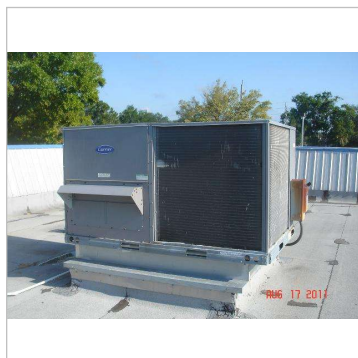
- 1.1.89 The building is served by a Carrier central forced-air package system, located on the roof. It is approximately 8 years old, and its components should last for twenty years if the system is well-maintained and inspected as part of a regularly scheduled maintenance program.

Figure 12A - Carrier roof top packaged system

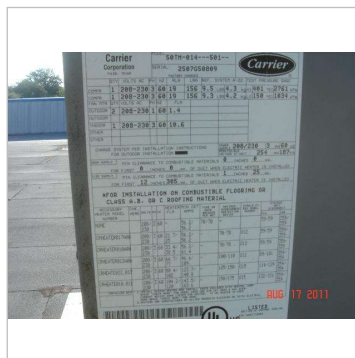
Figure 12B - Data tag on roof top unit

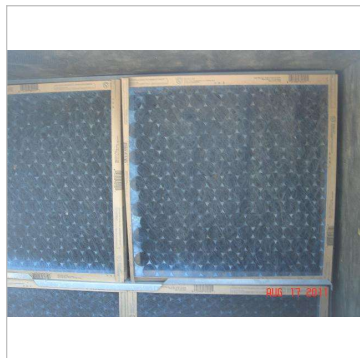
- 1.1.91 The return-air compartment is in acceptable condition.

Figure 13A - Filters located under a panel in the roof top unit

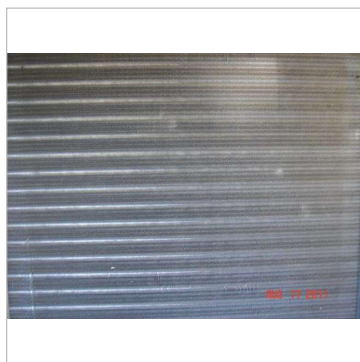
- 1.1.92 The evaporator coil is functional and clean.

Figure 14A - Evaporator coil

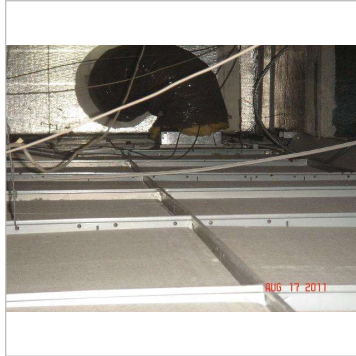
- 1.1.96 The ducts are a modern fiberboard type trunk lines with flexible type takeoffs that are in working order. They are comprised of an inner and outer sleeve that encompasses fiberglass insulation.

Figure 15A - Fiberboard trunk with flex duct to register
